PHASE I ENVIRONMENTAL SITE ASSESSMENT

UNIVERSITY OF THE DISTRICT OF COLUMBIA

4200 Connecticut Avenue, Northwest
Washington, District of Columbia 20008

EMG Project #: 89419.08R-009.017
Date of Report: February 3, 2009
On-Site Date: December 3-5, 2008

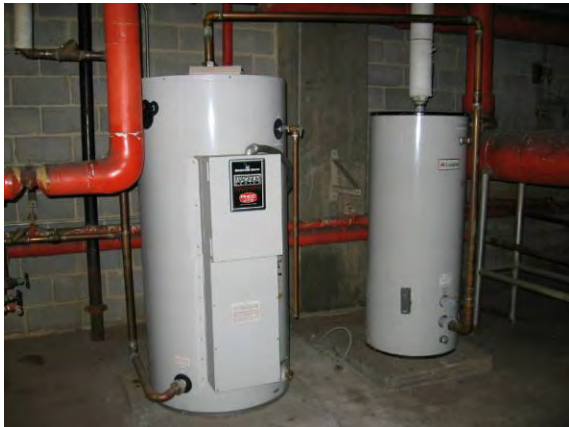
Domestic hot water is generated by electrically powered water heaters in each building. The associated piping was observed to be insulated with fiberglass and suspect asbestos.

Photo #9: Electric domestic hot water heaters in each building

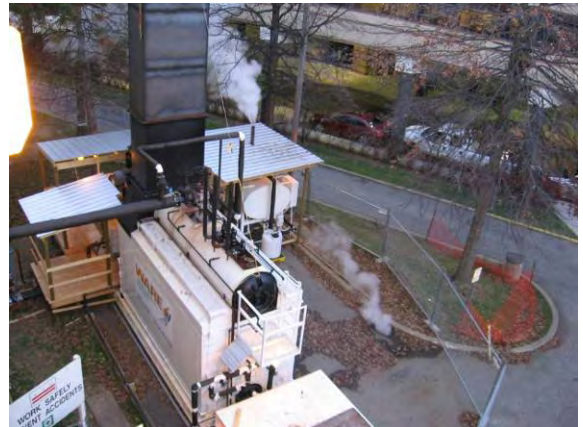
- Heat is currently supplied to the Project from a temporary natural gas-fired boiler located on the eastern exterior elevation of Building 43. According to Emanuel Yeoman, the Project formerly had two fuel oil-fired boilers installed inside Building 43 that were removed and two combination natural-gas and fuel oil-fired boilers are being installed. Where observed, piping associated with the heating system was insulated with fiberglass and suspect asbestos-containing thermal system insulation.
- Air-conditioning is supplied to the Project via chillers located on the rooftop of Building 43.

Photo #10: Temporary natural gas boiler at Building 43

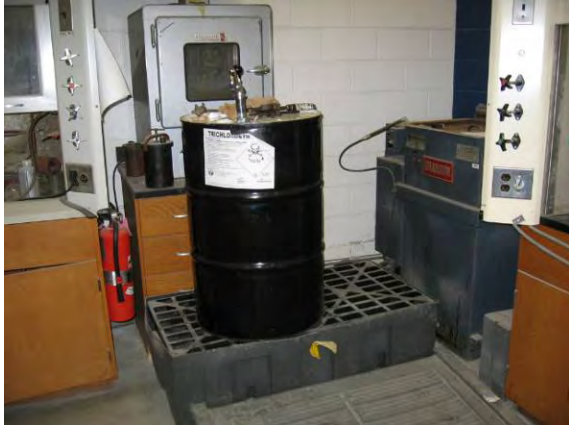
Photo #19: Waste TCE in 55-gallon drum with secondary containment in Building 42

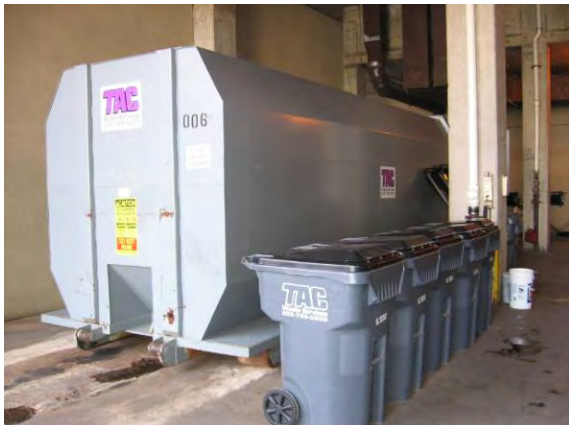
- A hydraulic trash compactor is located at the Project. PCB-containing hydraulic fluid has not been manufactured since 1977. Therefore, based on the date of installation, PCB-containing hydraulic fluid is not likely to be found in the operating system. No visual indication of leakage was observed in the area of the equipment. No further action or investigation is recommended regarding the trash compactor at the Project.

Photo #23: Hydraulic trash compactor at Building 38

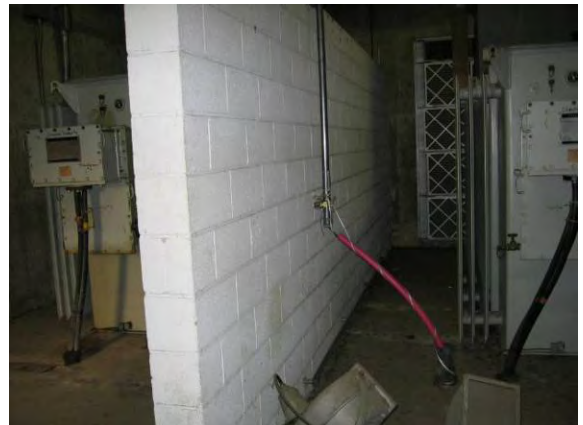
- EMG identified utility-owned transformers which are not classified regarding PCB content. This equipment appeared to be in good condition with no evidence of leaks. The utility is the financially responsible party for maintenance of the transformers. No further action or investigation is recommended regarding the transformers at the Project.

Photo #24: Utility-owned transformers in interior electrical vaults in each building

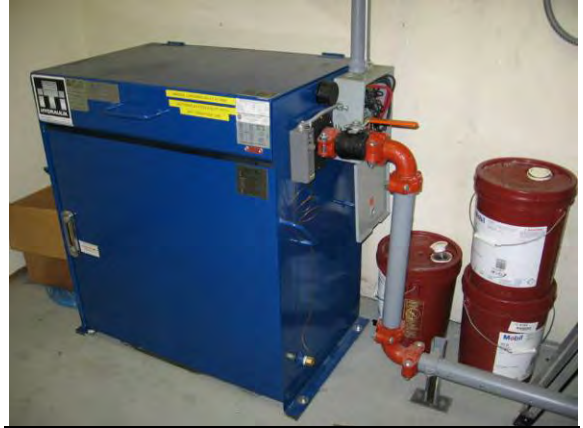
- The Project maintains one hydraulic elevator, which is located in Building 38. Because the unit was installed prior to 1978 (the USEPA banned the manufacturing of PCB-containing hydraulic fluid in 1976, and the manufacture of PCBs ceased in 1977), EMG is of the opinion that the elevator hydraulic fluid potentially contains PCBs. No visual indication of leakage was observed in the area of the elevator operating equipment. The hydraulic elevator unit at the Project should be periodically inspected for leakage. If leakage is identified, the unit should be repaired and any fluid or fluid-soaked waste disposed of in accordance with applicable federal, state, and local regulations.

Photo #26: Hydraulic elevator

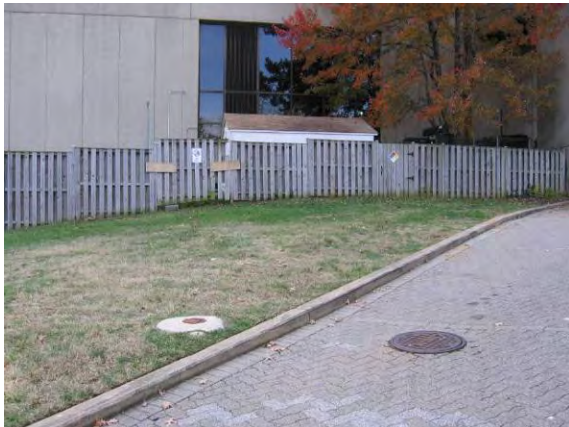
- Groundwater depths beneath the Project ranged from approximately 11 to 23.5 feet and groundwater movement was towards the northeast. Groundwater mounding was evident, caused by differential water retention in the crushed concrete fill used to replace native soils.

Photo #33: One of eight ground water monitoring wells located north of Building 43

- EMG recommends continued groundwater sampling and laboratory analysis in accordance with applicable regulations and requirements in order to achieve regulatory closure.

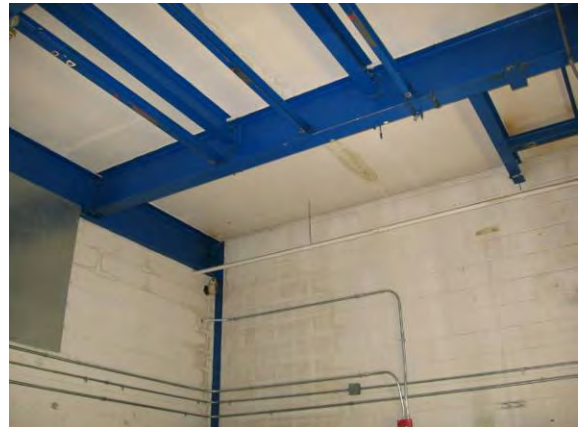
- Approximately two square feet of water damaged painted drywall ceiling and ten square feet of water damaged painted concrete masonry walls in the break room of the Building 43 C level. Mr. Emanuel Yeoman was unaware of the cause of the water damage.

Photo #34: Water damaged painted dry wall in break room of Building 43

Prior to remediation by personnel specifically trained in the handling of hazardous materials, a mold assessment should be conducted by a health and safety professional with experience performing microbial investigations. Additional information about the source of the moisture is included in EMGs Property Condition Assessment (PCA) report.

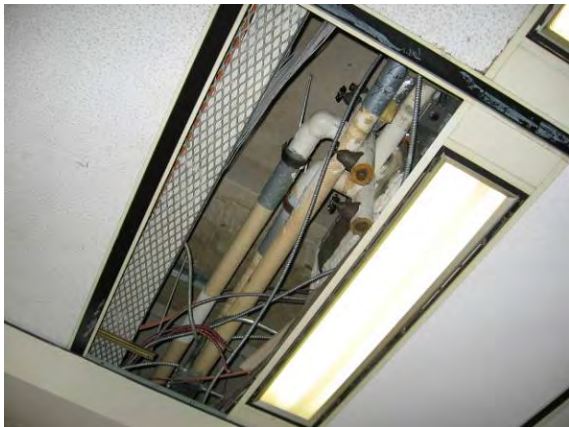
- According to Mr. Emanuel Yeoman, there is a window leak that floods Room 114B of Building 42 when there is a heavy rain.
- Approximately 16 square feet of ceiling tile was removed from the women's room on Level C of Building 32 due to water damage from a burst pipe on the B level in December of 2008.

Photo #35: Water damaged ceiling tile in Building 32

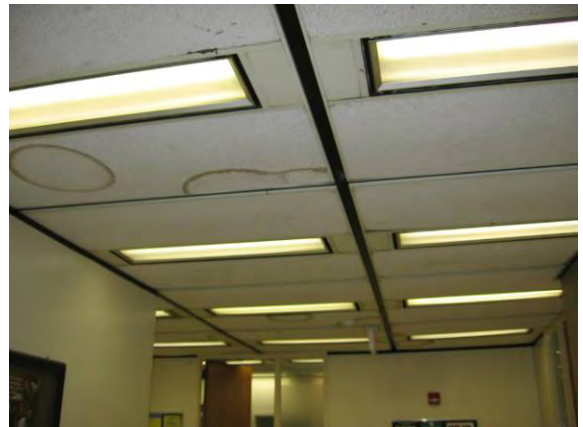
- Water staining on the concrete in the stairwells of Building 38 and Building 39 was reportedly caused by leaking sky lights. According to Mr. Emanuel Yeoman, these leaks have been repaired.

Photo #36: Water damaged ceiling tile in Buildings 38 and 39

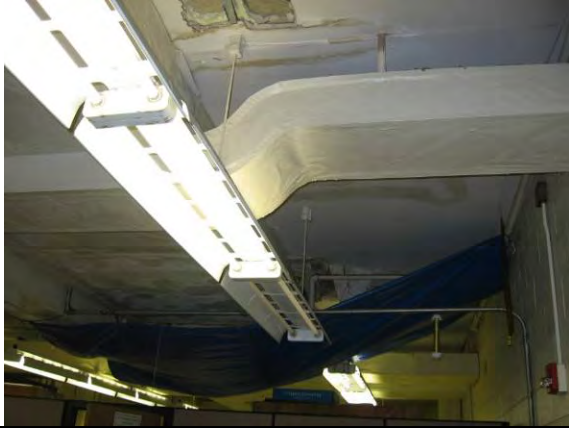
- According to Mr. Emanuel Yeoman, there is a window leak that floods Room 103 of Building 38 when there is a heavy rain.
- Approximately 50 square feet of water damaged painted drywall ceiling in the copy room on level C of Building 39. According to Mr. Emanuel Yeoman, this damage was caused by the leaking expansion joint above the area.

Photo #37: Water damaged painted drywall ceiling in the Building 39 copy room

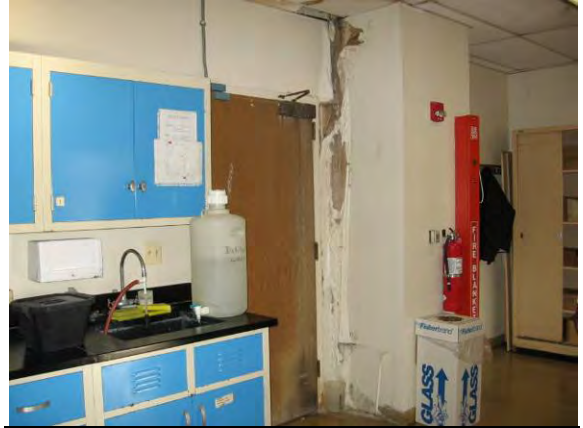
- Approximately 12 square feet of suspect mold and water damaged drywall and ceiling tile was observed in Room 311 of Building 44, as well as 20 square feet of water damaged floor tiles in the nearby hallway. According to Mr. Emanuel Yeoman, this damage was caused by a roof leak and the roof has since been repaired.

Photo #38: Water damaged ceiling tiles, drywall, and floor tiles in Building 44 Room 311

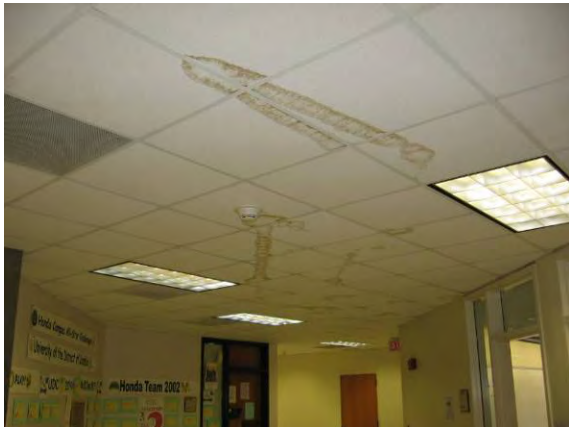
- Significant water damaged ceiling tiles, dry wall, and carpeting was observed on the fifth, fourth, third, second, and first floors of Building 41. According to Mr. Emanuel Yeoman, the damage was caused by a leaking condensation pan and an overflow from a janitorial sink that flooded the building.

Photo #39: Significant water damage throughout Building 41

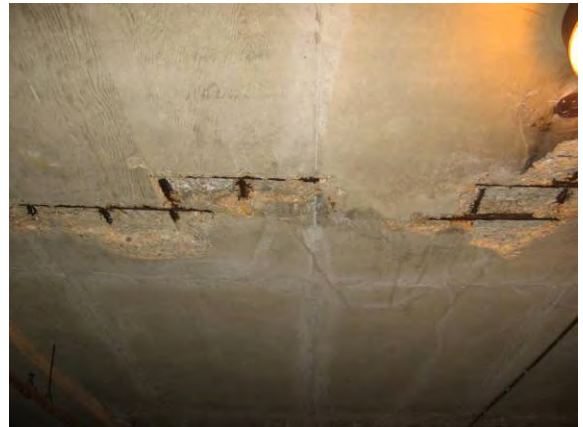
- Significant water damage to concrete was noted throughout the parking garage.

Photo #40: Significant water damage throughout the parking garage
